Constructing a Superflat Concrete Floor Slab

Teamwork, craftsmanship, and experience combined to make a recently-constructed warehouse floor slab twice as flat as was specified.

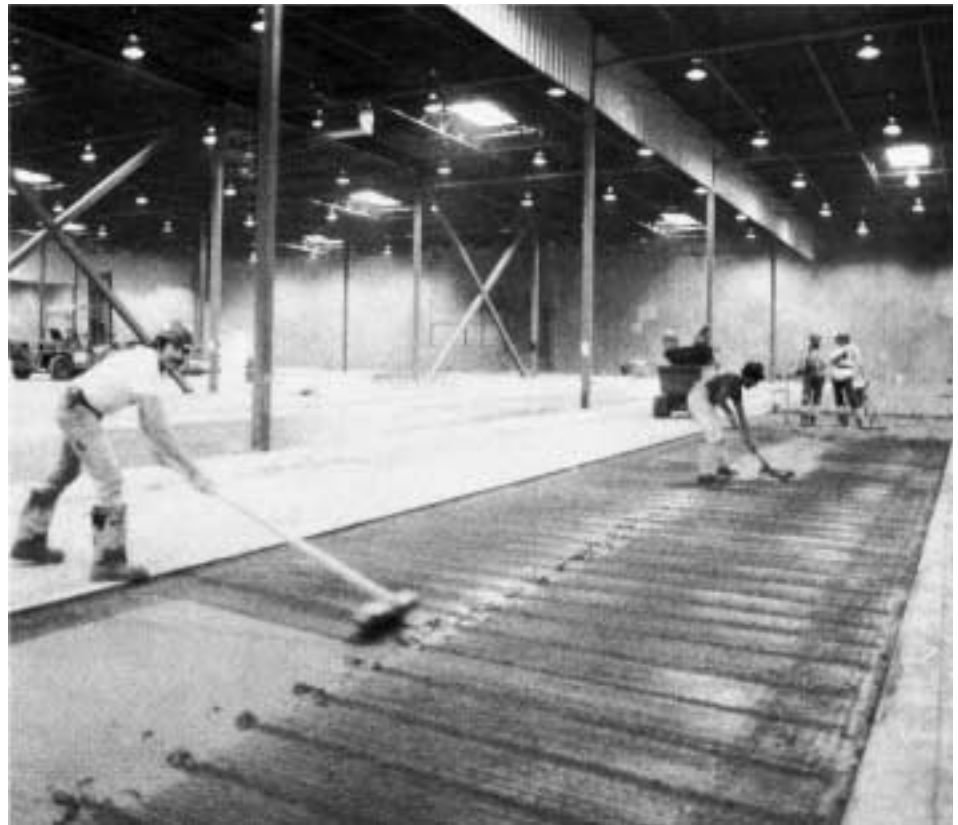
After the base course was struck off one inch below the forms and had partially set up, the surface was broomed to insure adequate bond with the top course.

The concrete subcontractor elected to perform an optional step at this critical juncture. To be absolutely sure that the topping is integral with the base (a must for the superflat floor to function effectively and without future separation), the surface of the freshly-placed base mix was broomed to help assure bonding. This step had to be fitted into the critical period of 20 to 60 minutes after base placement.

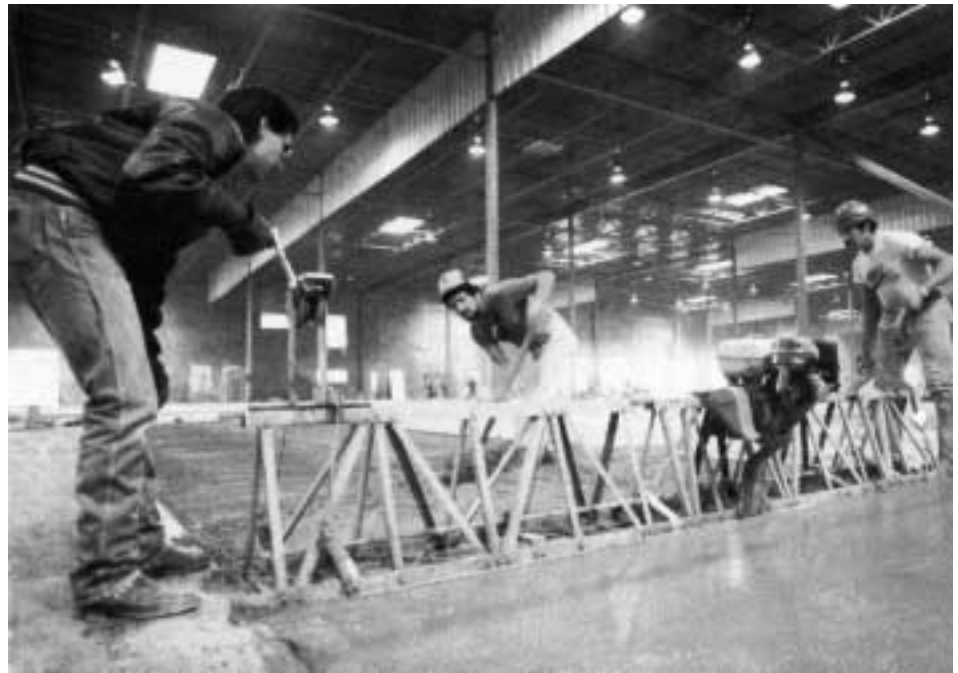
The top course, placed 20 to 60 minutes after the base course, was struck off with a vibrating screed, which also improved the bond between the courses.

Immediately after placement and strike-off of the base course came placement of the topping. The 'window of opportunity' here was critical, with the topping needing to be placed, for complete integration

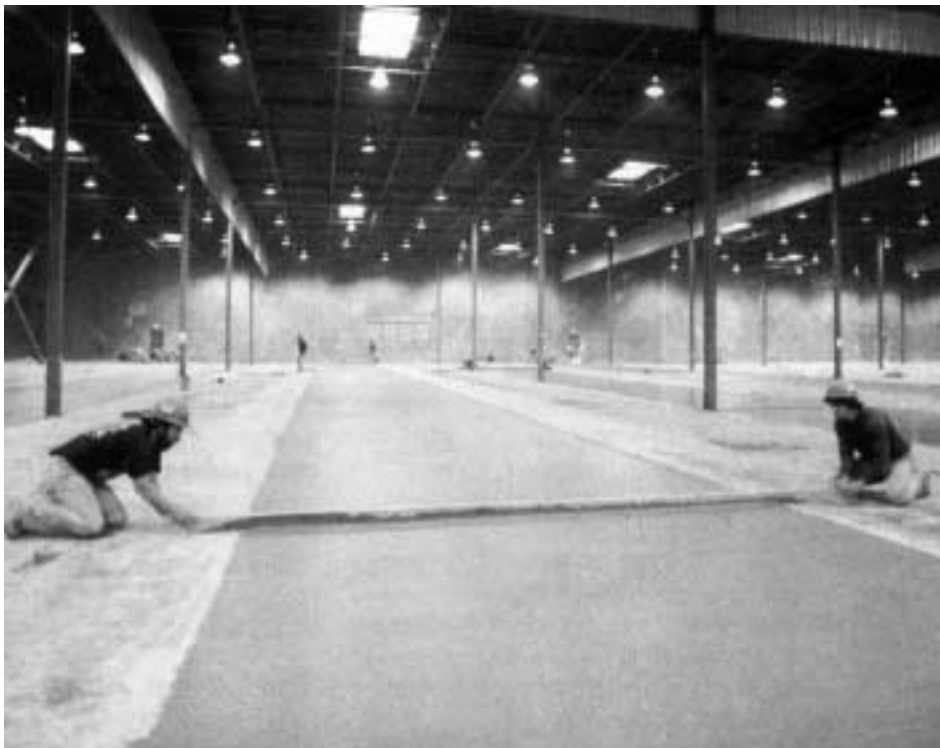
Following initial strike-off and two transverse strike-offs, the surface was power floated then given another transverse strike-off.

The first step after placement was vibratory strike-off, this operation also helping to improve the bond between base and topping. After strike-off (another judgment call based on experience) came two hand transverse strike-offs using magnesium straightedges. Then followed power floating, which was followed by yet another transverse strike-off, then another power troweling, followed by cutting and filling the concrete surface using the highway straightedge.

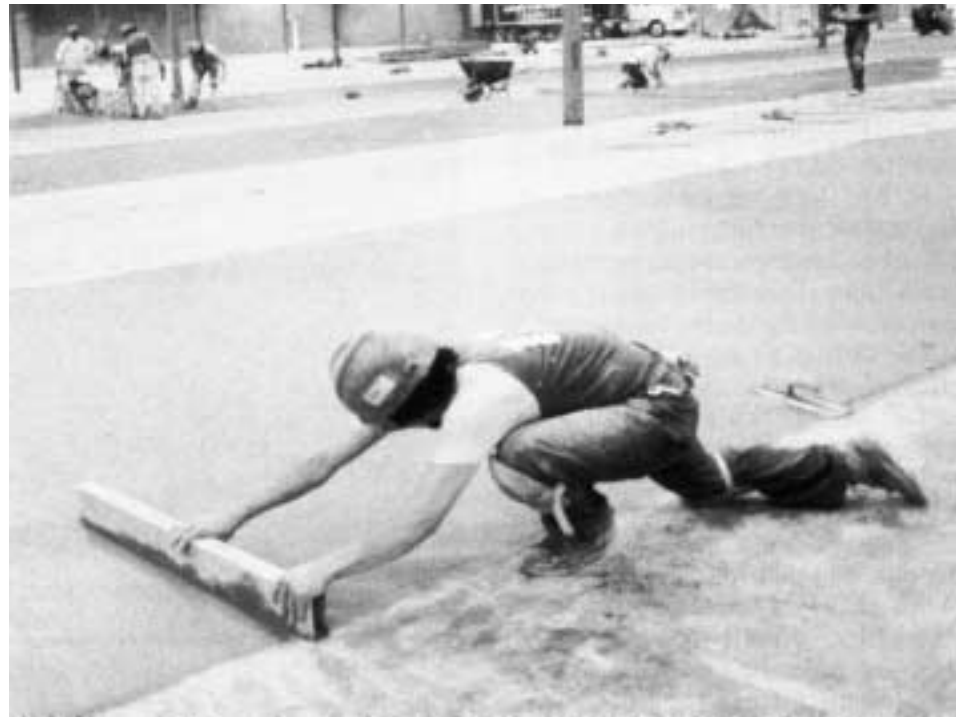
Hand working the edge of the slab with a magnesium straightedge is another skilled finishing operation essential to producing high quality superflat floors.

Another finishing step at the Freightliner job further emphasizes the need for skilled finishers: hand working of the slab edge. Here, the finisher, using a 4 ft. (1.2m) long straightedge, his vision, and a feel for superior craftsmanship, carefully worked the critical edge areas to guarantee level and straightness, by wiping out any dips and swales.

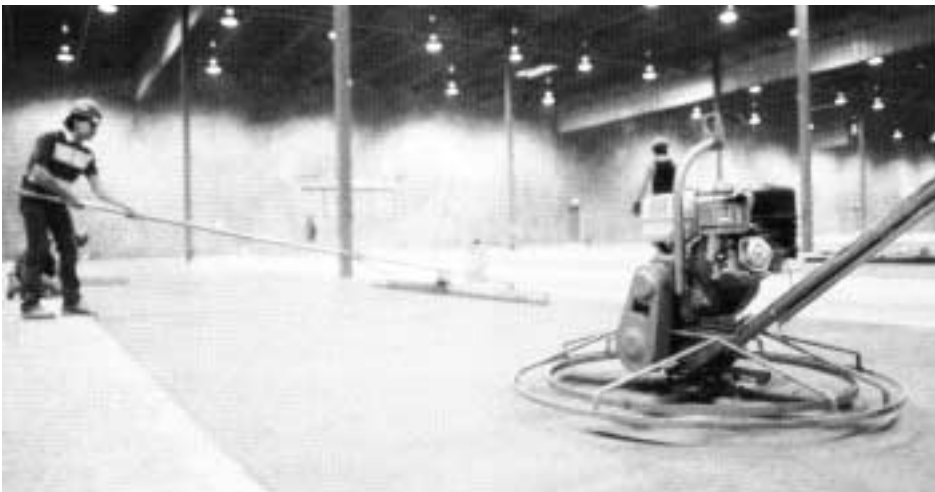
Repeated cutting and filling the concrete surface with a highway straightedge, combined with power troweling, is essential to producing superflat floors.

At this point, even the casual observer would note the differences between superflat and ordinary slab construction. The use and re-use of the highway straightedge is on of them. When and how to use the highway straightedge is a real judgment call. Using it at the wrong time, in the wrong way, will cause a lot of problems.

'Re-straightening' sums it up- the purposeful reapplication of the straightedge time and again as required to be absolutely sure that you are not straying from the all-critical level established by the forms or the previously placed slabs- and doing it before the concrete sets up. The final quality of the floor depends in large part upon the skill of the craftsman handling the highway straightedge. As stated in an article by William Phelan in the January, 1989 issue of Concrete Construction: "Flatness (the F_F value) is

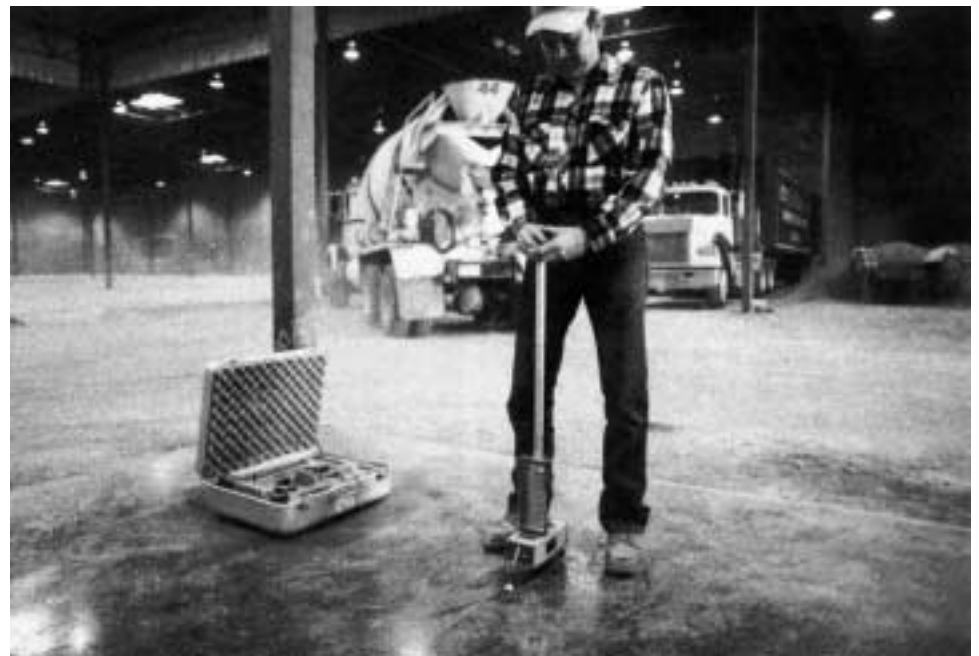
The non-superflat slabs were measured for compliance with the specified F-numbers by taking readings with a Dipstick the morning after placement.

that will be used for office, storage, and other non-critical uses. These were specified at a modest F_F 35 and F_L 27, but achieved F_F 109 and F_L 104. The flooring consultant commented that these slabs exceeded the specified flatness requirements by a greater margin than any other floors he had ever measured.
